PROCEEDINGS OF THE INTERNATIONAL COURSE

CERAMIC MATERIALS

IN BUILDING HERITAGE:

CONSERVATION PROBLEMS AND INTERVENTION

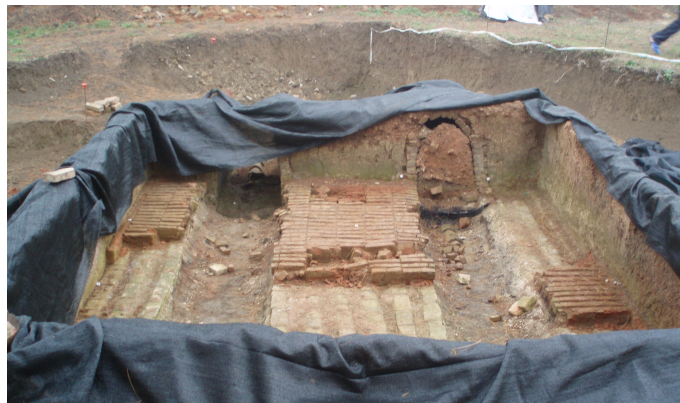
Image 1. Late Medieval ceramic furnace in the Po valley near Piacenza (Italy).

The last step is the firing of the dried artifacts. At the beginning, firing was made preparing heaps of dried bricks mixed with wood, to which fire was then set. This firing system was characterized by different temperature and atmosphere in the various zones of the heaps, so that the finished products showed variable characteristics, even in different points of a single artifact. Best results were obtained, since the Roman period, with the use of especially developed furnaces (image 1), [10].

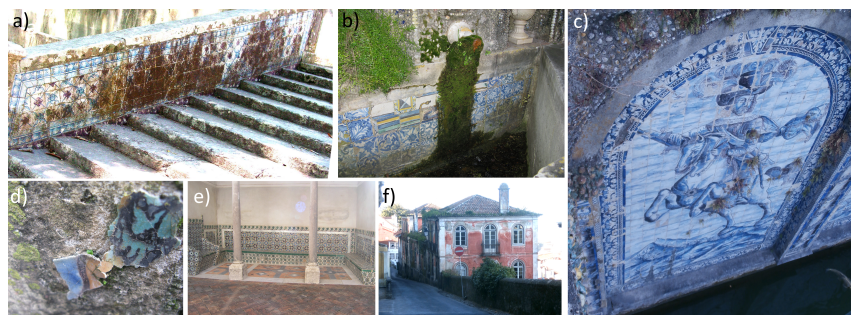
Image 1. Examples of biodeterioration on different architectural ceramic materials: (a) North-facing tile panel from Casa da Pesca covered with a brown biofilm, (b) Tiles from a fountain located in Fronteira Palace with phototrophic microorganisms, mosses and vascular plants, (c) Tiles from the Fronteira Palace with vascular plants in the mortars, (d) glaze detachment due to growth of bryophyta in the Fronteira Palace, (e) ceramic floor tiles with dark coloured biofilm and (f) ceramic roofing tiles with dark biofilm and vascular plants colonization.

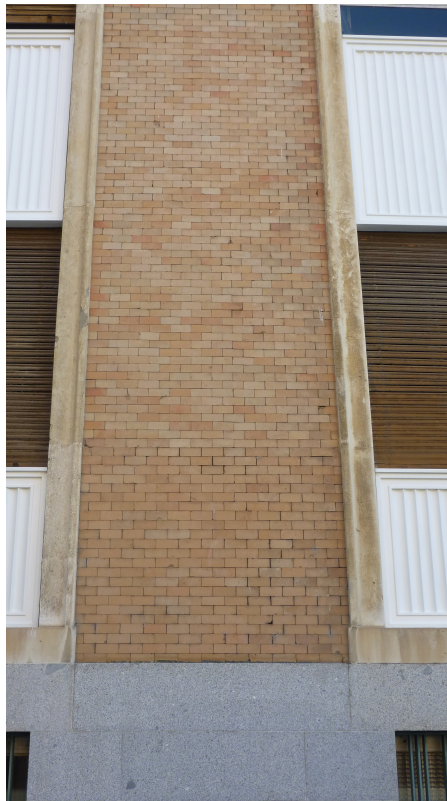
Image 1. Bricks wall of the main façade of the School of Medicine, Complutense University of Madrid, Madrid, Spain. The wide variety of bricks with different colour can be seen.

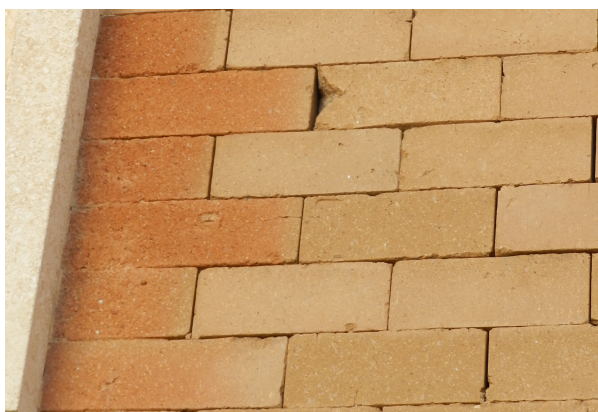
Image 2. The variation of colour and roughness of bricks is linked to decay processes. Main façade of the School of Medicine, Complutense University of Madrid, Madrid, Spain.

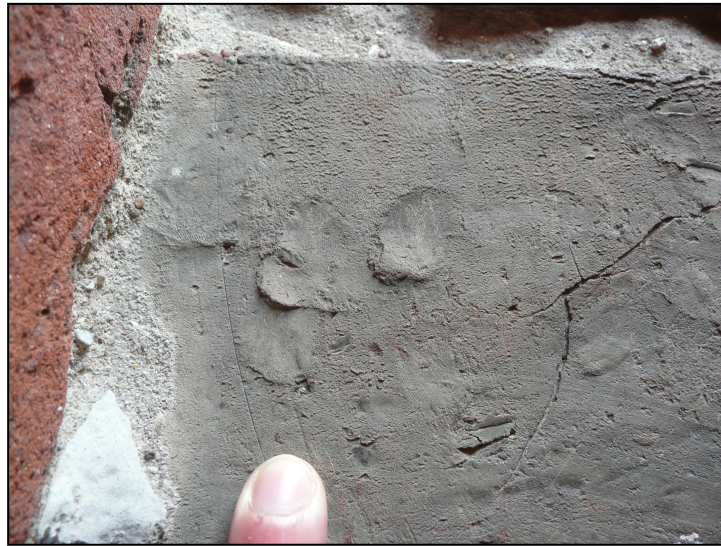
Image 1. Historical brick showing intense soiling

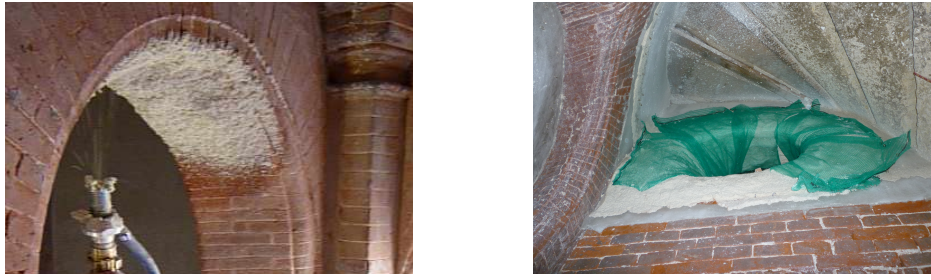
Image 2. Mechanical application of the poultice (left) and use of a net for guaranteeing good contact of the poultice with the masonry.

In the case of very fast drying (as in the presence of high temperature and/or high air flow) the use of textile sheets on the surface of the poultice can be considered, to slightly slow down the initial drying. Depending on the situation, it might be necessary to repeat the application to obtain a better effectiveness. It is of crucial importance that the poultice maintains a perfect contact with the substrate during the whole extraction process, otherwise the desalination process will stop. In order to guarantee a good contact, a plastic net can be used to press the poultice against the substrate (image 2 right).

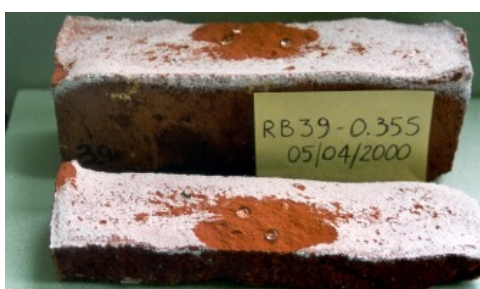
Image 4. Spalling of the water repellent layer in a brick after a salt crystallization test in laboratory.

One of the main risks is the worsening of the damage that occurs if the water repellents are applied on a substrate with a high salt content [5]. As the water repellent inhibits liquid moisture transport, the salts, which can be transported only in solution, crystallize and accumulate just beneath the treated layer. This may result in spalling of the treated zone (image 4).

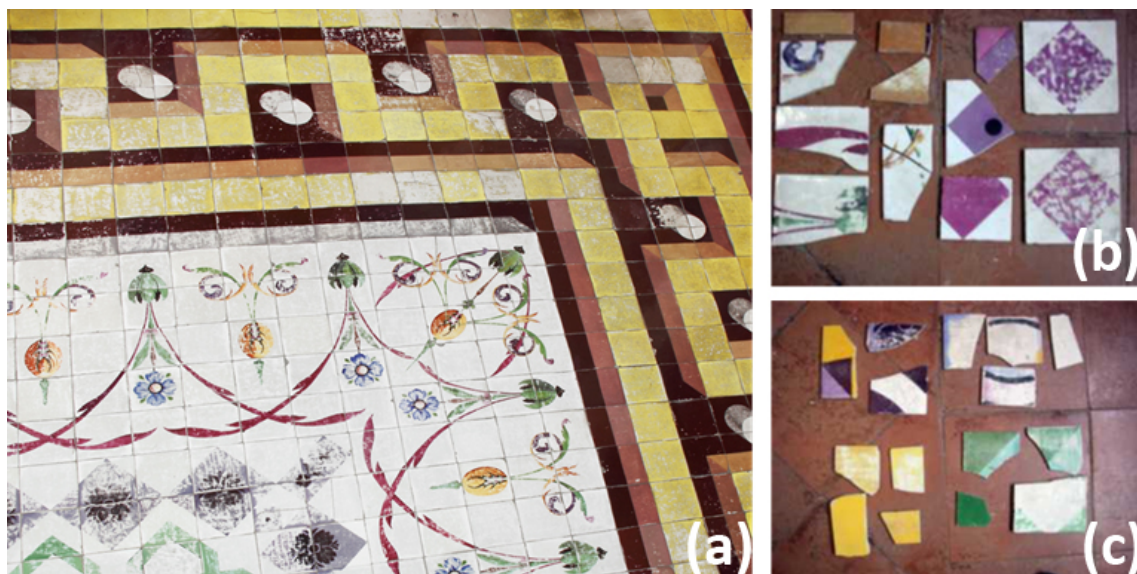
Image 1. (a) the polychrome porcelain tile floor in the *Sala de Compañía* of La Casa del Labrador; (b) and (c) the twenty nine tile shards, stored in the palace, that were choose for study.
